Manhole Inspection Summary

Manhole # S23MM1005MH

Location Address: **4600 FALLS RD**

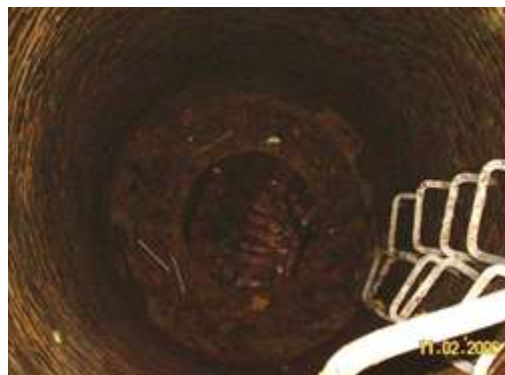
Top View

Corroded steps. Bench debris.
